DELAWARE RIVER BASIN
SWIFTWATER CREEK, MONROE COUNTY
PENNSYLVANIA
NDS ID PA. 00776
DER ID 45-134

LAKE SWIFTWATER DAM

PHASE I INSPECTION REPORT NATIONAL DAM INSPECTION PROGRAM

NDS I.D. NO. PA 00776
DER I.D. NO. 45-134

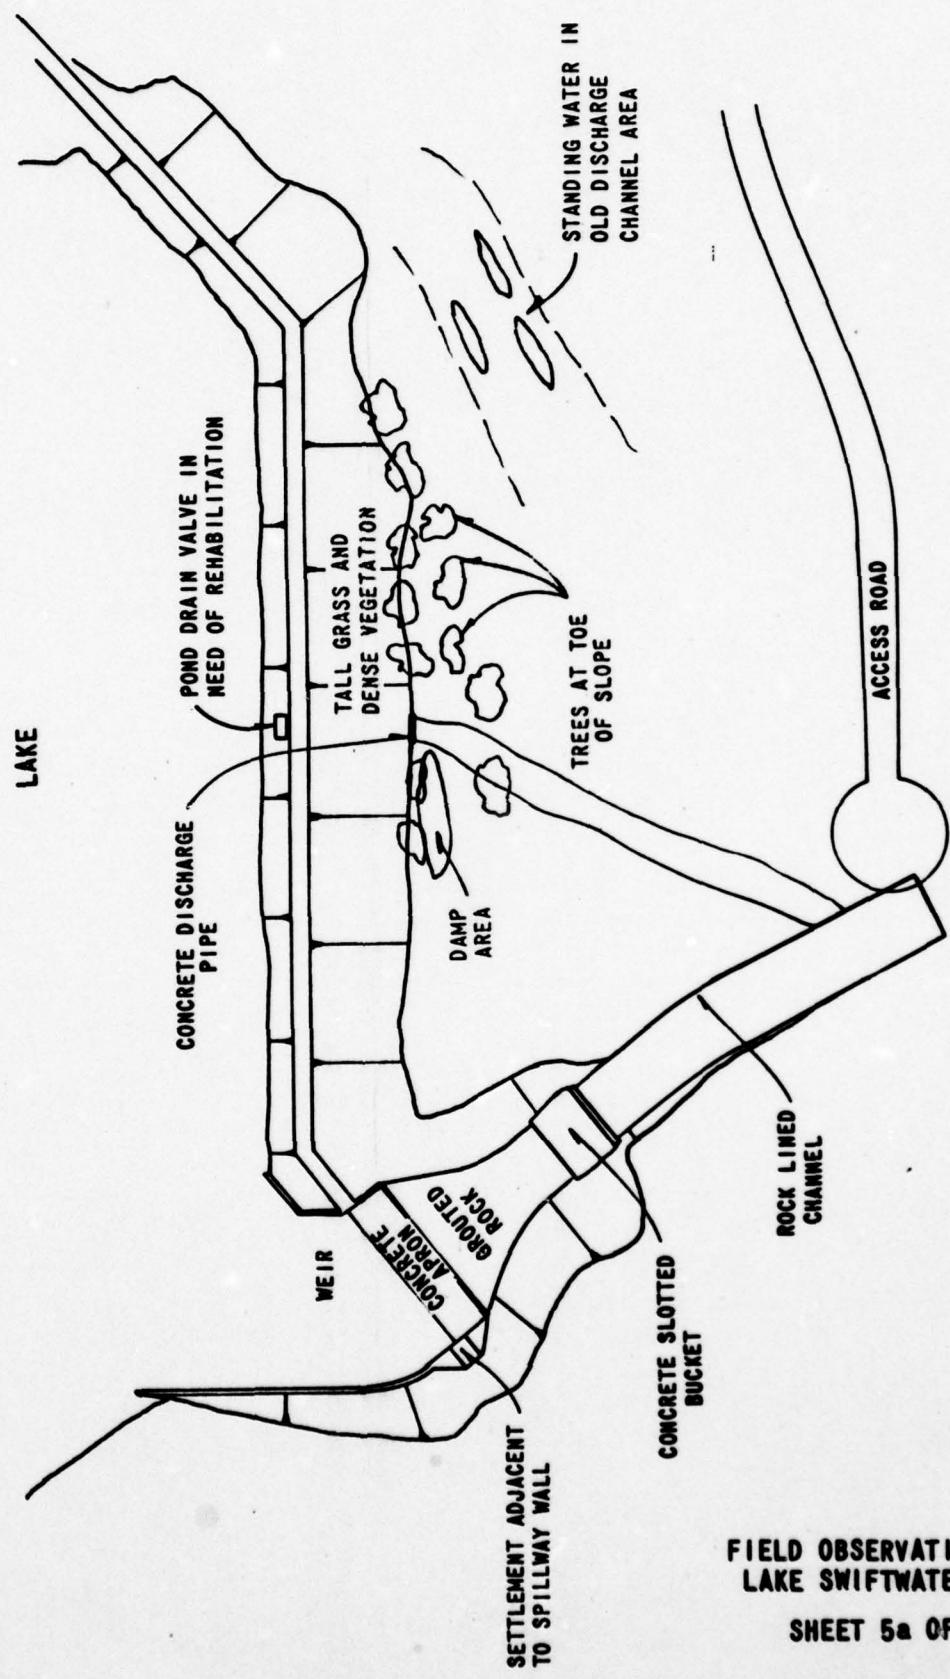
SHEET 5a OF 11

b. Dam. During the visual inspection, there were no indications of distortion in alignment or grade that would be indicative of movement of the embankment or foundation. Inspection of the downstream slope and adjacent downstream areas disclosed some marshy areas located along the old spillway channel, as shown on sheet 5a. A pool of stagnant water was also noted at the pond drain outlet, but there was no evidence observed of seepage into the pool from the edge of the pond or surrounding area. The upstream slope was inspected and found to be in reasonably good condition with extensive vegetation between the riprap. The location of the original spillway, which was replaced with an embankment, was clearly defined by a difference in vegetation. The junction between these two areas is assessed to be excellent. The upstream slope of the original embankment shows signs of undulation, which is not considered to be significant but rather expected for a structure of this age. The crest has a measured width of 10 feet, and a level profile along the crest showed the maximum difference in elevation was 14 inches. The low point is at the junction of the embankment and left abutment, as shown on Plate 5a, Appendix B.

Inspection of the dam disclosed no evidence of apparent past or present movement that would indicate existing instability of the structure. The seepage and standing water noted along the old spillway discharge channel appear to be stable and apparently have been stable for many years. The observed seepage was clear with no signs of piping. The spillway is in fair condition with some spalling, which should be monitored yearly and after each severe storm and repaired as necessary. The pond drain gate is considered to be in poor condition and should be rehabilitated. The low point on the dam is shown on sheet 5a, Appendix B, which is the first point of overtopping.

A marshy area containing cattails was noted along the original spillway channel. See Sheet 5a. A pool of stagnant water was also noted at the pond drain outlet but there was no evidence of seepage observed in the pool.

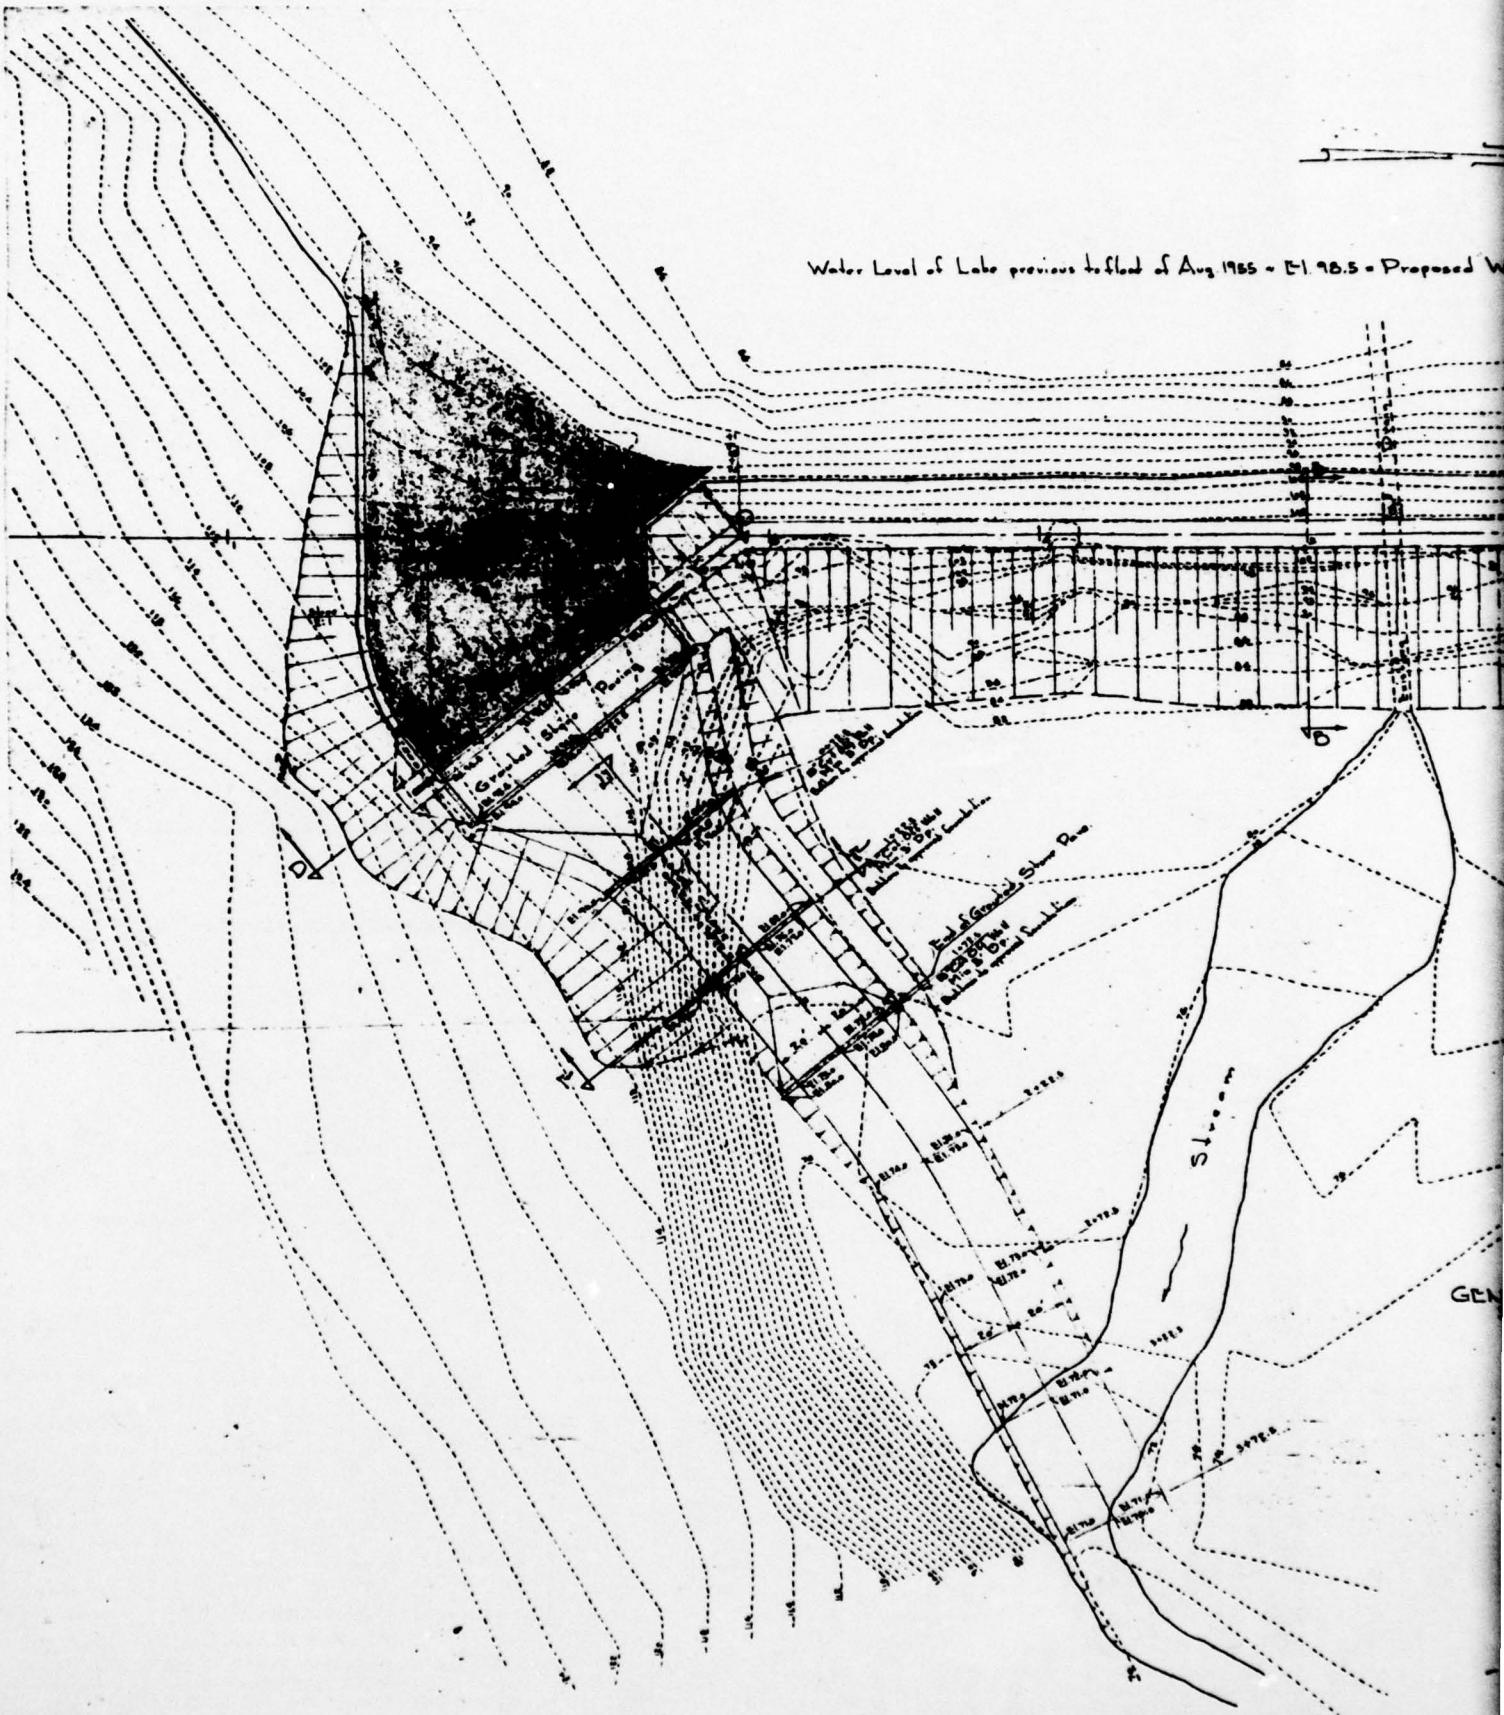
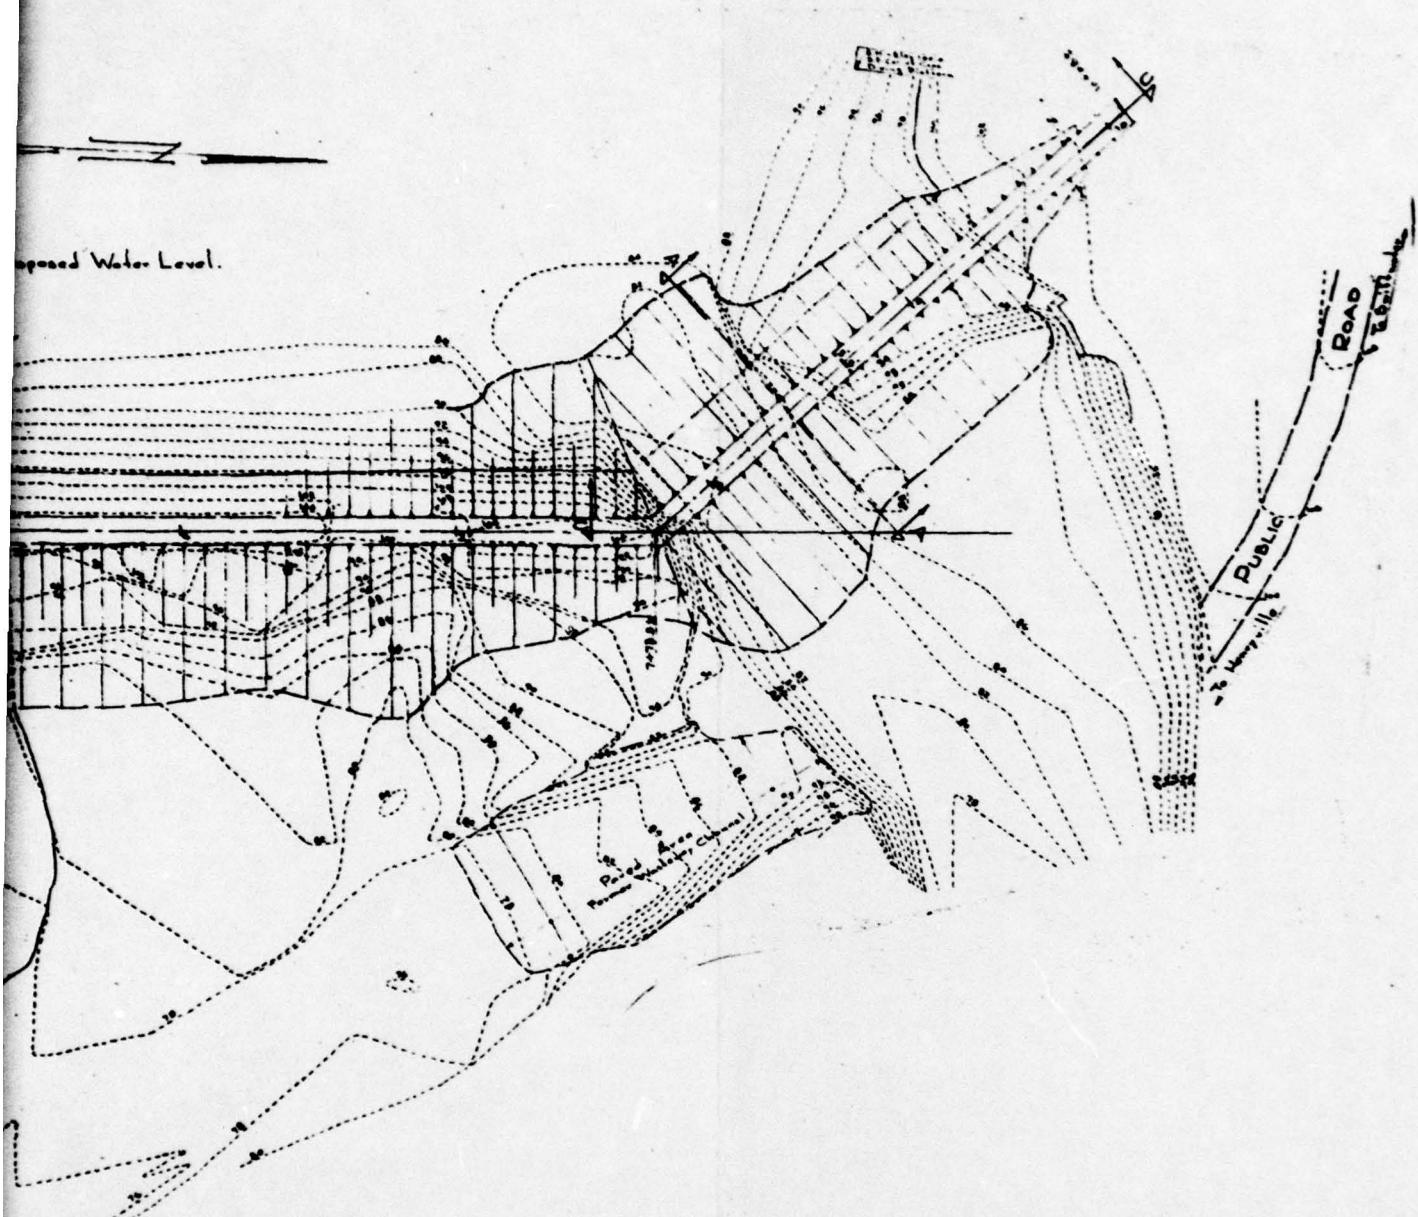
PLATE 2

GENERAL PLAN
Scale 1" = 30'

NOTE: THE SPILLWAY SHOWN HERE WAS REBUILT IN
1970 AND CAN BE SEEN ON PLATE 5

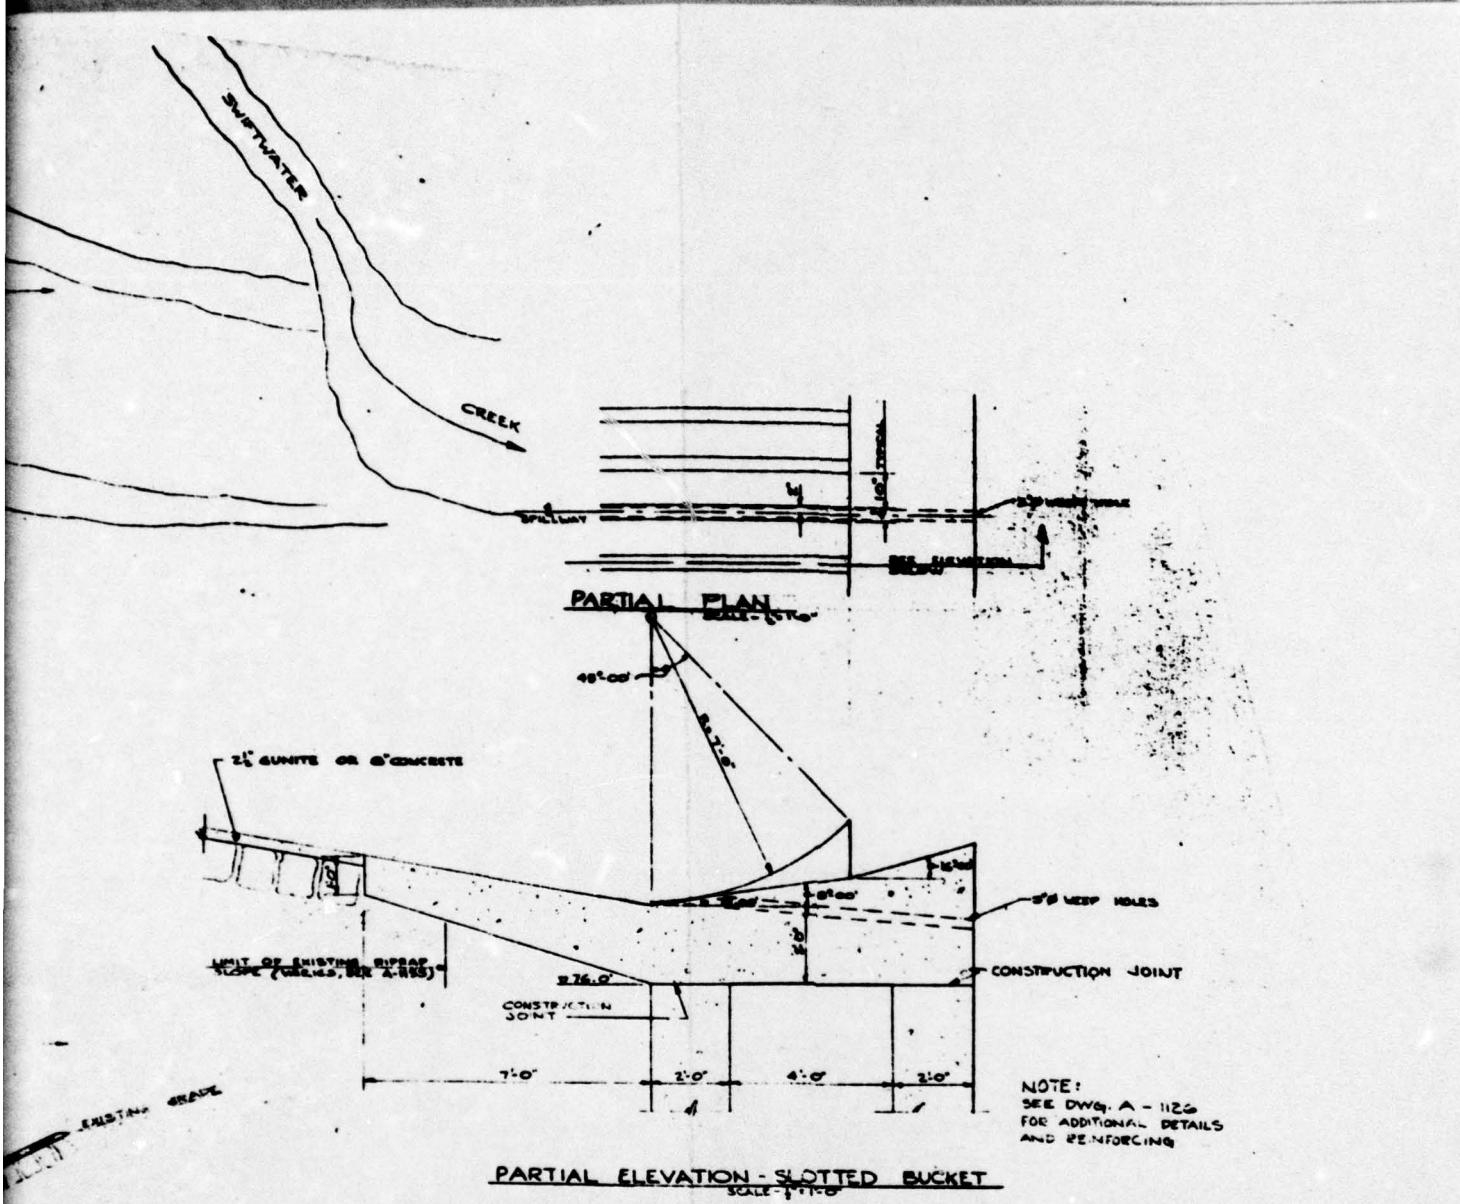
PLATE 5

TYPICAL PLAN AND PROFILE OF
RECONSTRUCTED SPILLWAY

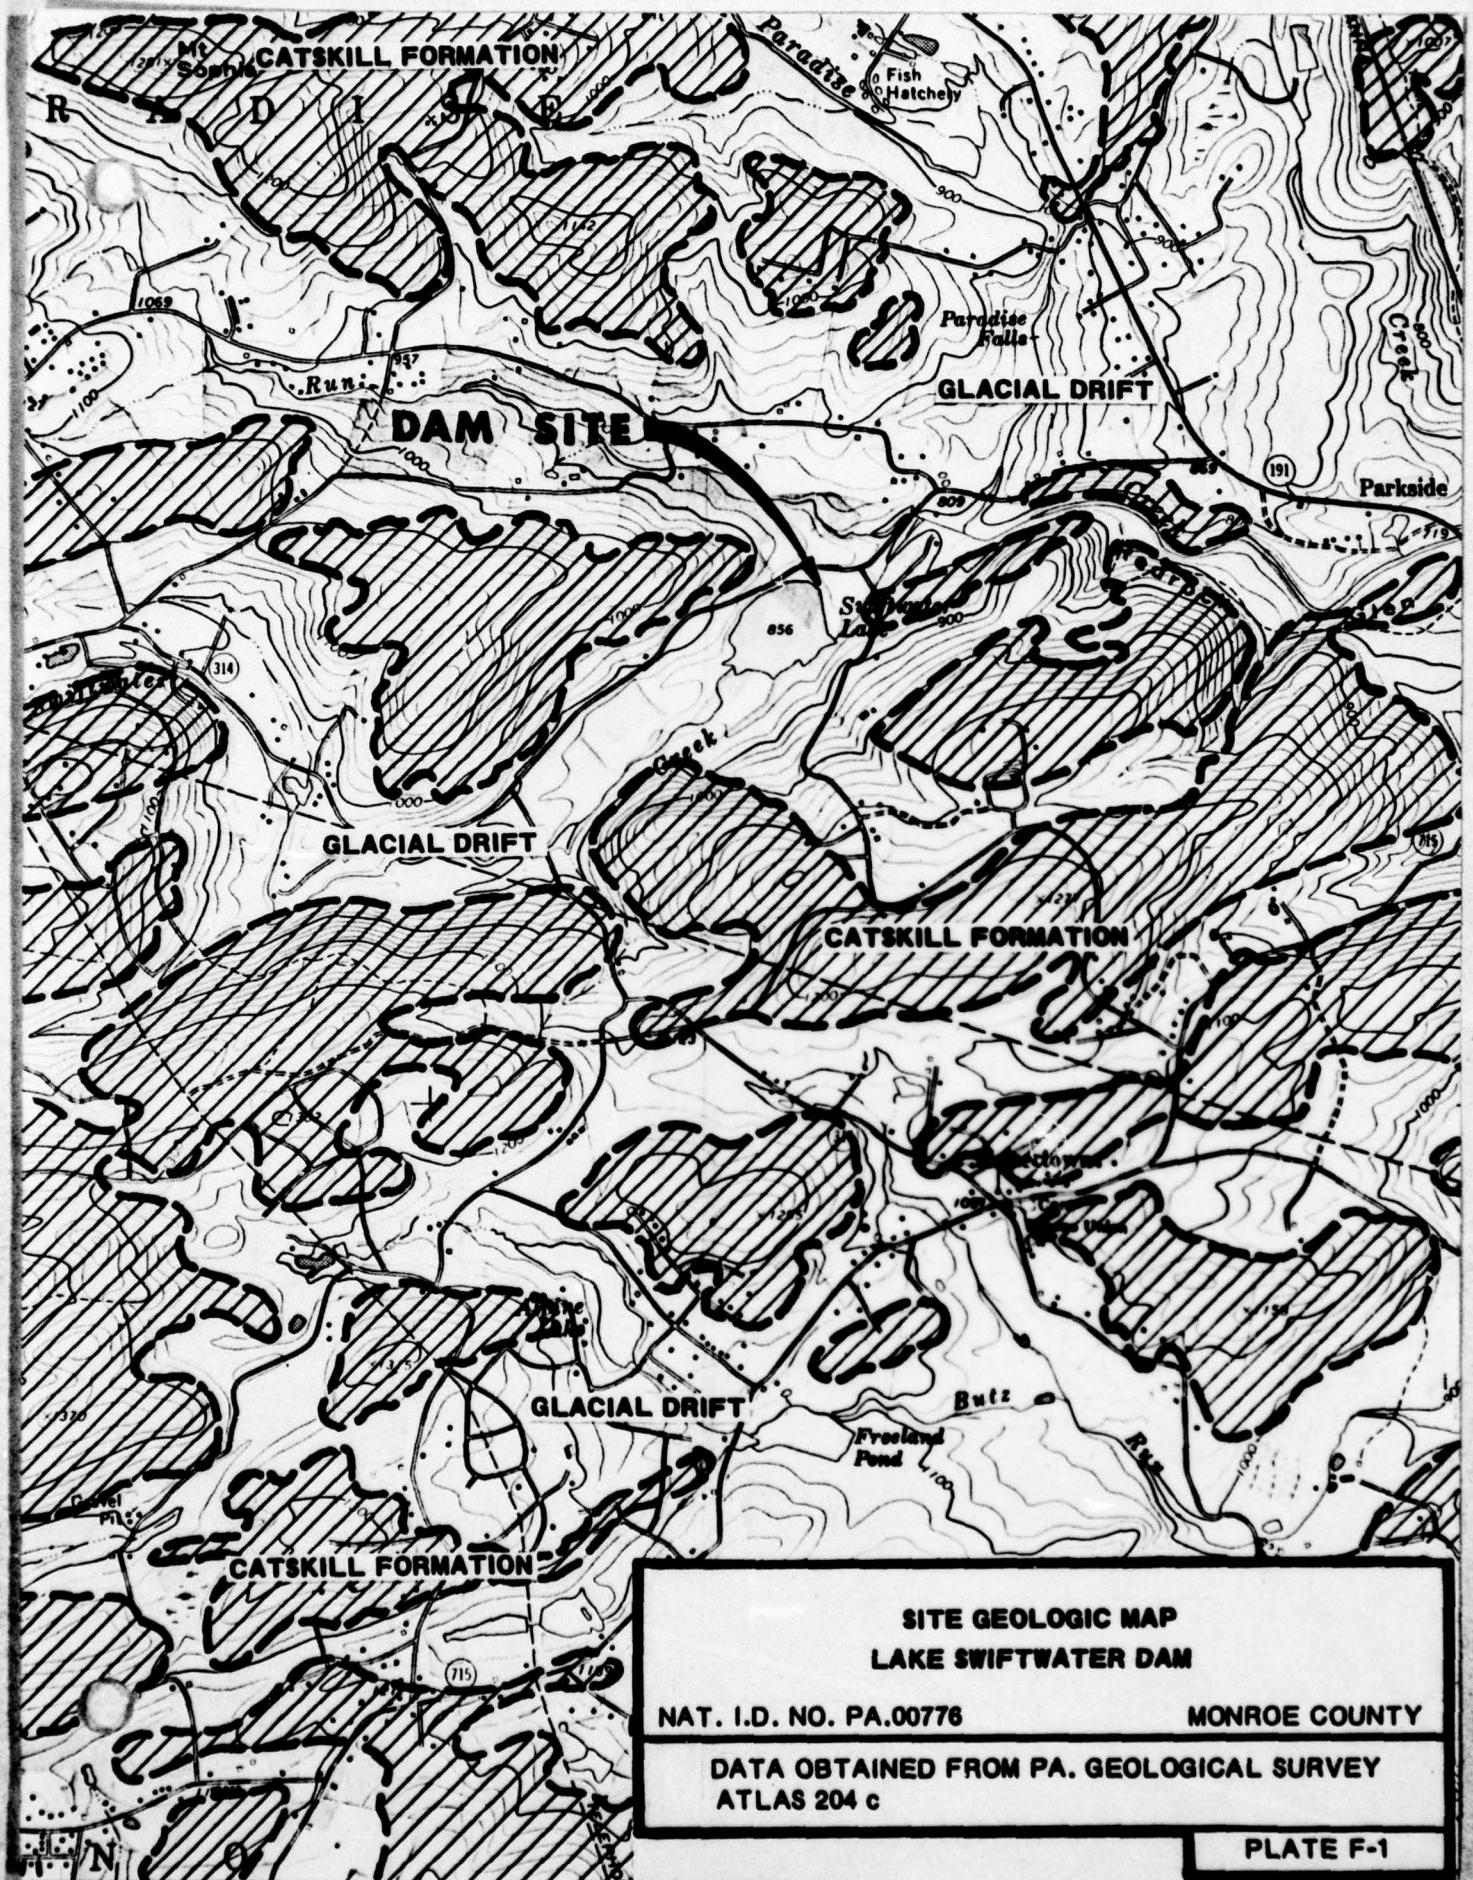
SITE GEOLOGIC MAP
LAKE SWIFTWATER DAM

No bedrock exposures were encountered during the field inspection. Information contained in the State of Pennsylvania, Department of Environmental Resources files indicates that the dam is founded upon "hardpan" consisting of glacial drift. As is typical for glacial deposits, seepage potential would be an inherent characteristic, particularly within the Swiftwater Creek channel area.

Seepage observed during the field inspection was located in the vicinity of the original spillway (left portion of dam) where a general marshy soil condition was encountered. Also, a pool of stagnant water was observed adjacent to the outlet conduit, but no indication of flow was observed.
